EVALUATION OF PAVEMENT IRREGULARITIES USING A MOBILE APPLICATION

Abstract: The research evaluated the surface conditions of the TA-642 road in Tacna, Peru, using the TotalPave application on smartphones to measure the roughness and passability of the pavement. Descriptive-exploratory analysis methods with a quantitative approach were employed, collecting data every 400 meters over a distance of 12.8 km at speeds of 80 km/h, utilizing the sensors and GPS of the mobile device. The results showed an International Roughness Index (IRI) of 3.78 m/km and a passability score of 2.58, both classified as "Regular" according to Peruvian standards. These values indicate that the road has surface irregularities that may cause discomfort and damage to vehicles during transit. The study confirms the potential of TotalPave to effectively assess pavement roughness in a versatile, economical, and reliable manner compared to traditional methods. This mobile application uses smartphone sensors to measure the vehicle's vertical acceleration and accurately estimate the IRI. In conclusion, the use of mobile applications enables the assessment of road conditions and the planning of timely maintenance in

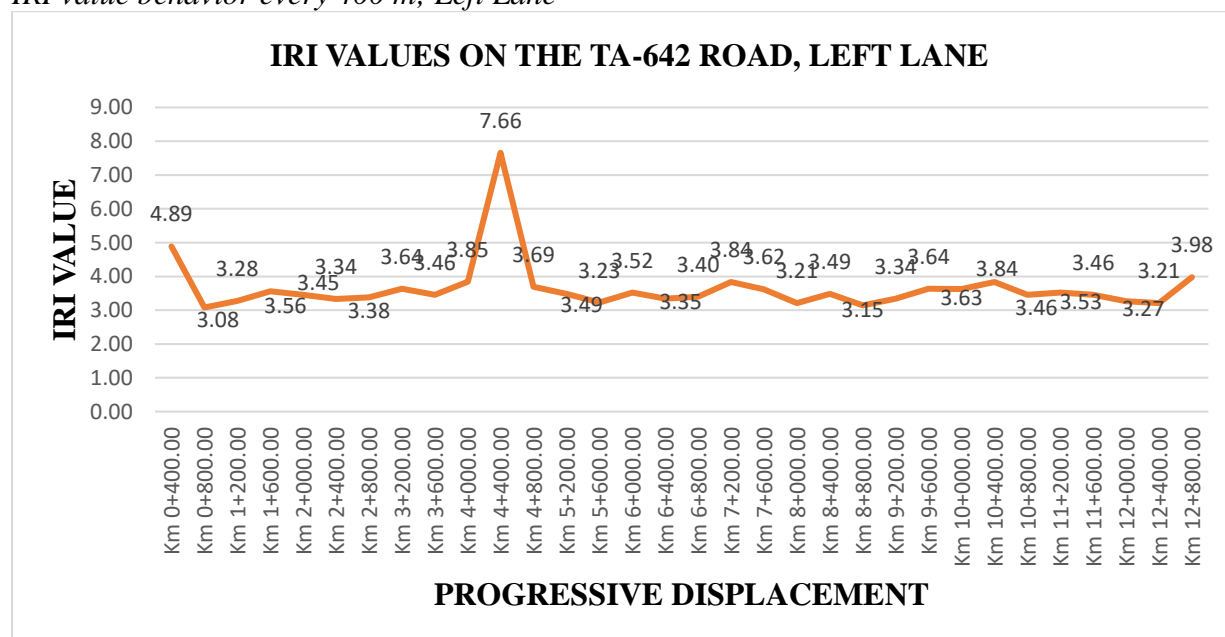
Figure 5 graphically illustrates the variation of the IRI in the left lane, showing a fluctuating behavior, where the IRI values coincide with the sections where the highest values were recorded in the table, which reaffirms the need for attention in those specific areas.

IRI value behavior every 400 m; Left Lane

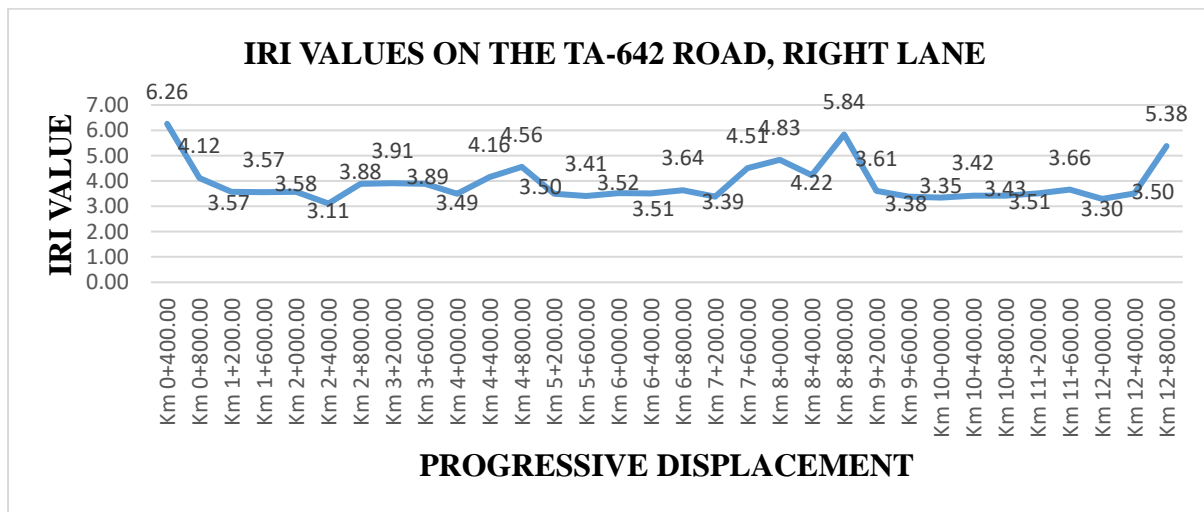
Similarly, Figure 6 represents the behavior of the IRI in the right lane, where the visualization allows us to observe that the values are more consistent, there are sections that require intervention, especially those that exceed the threshold of 4.0 m/km, which is considered a critical limit for surface quality.

IRI value behavior every 400 m; right lane

Figure 6 illustrates the behavior of the IRI in the right lane, showing a lower variability compared to the left lane. However, the IRI value of 6.26 m/km at the start of the route indicates that there are critical sections that need to be addressed. This finding is consistent with the literature suggesting that variations in the IRI may be associated with factors such as traffic type and weather conditions, highlighting the importance of further analysis to understand the causes of impairment.

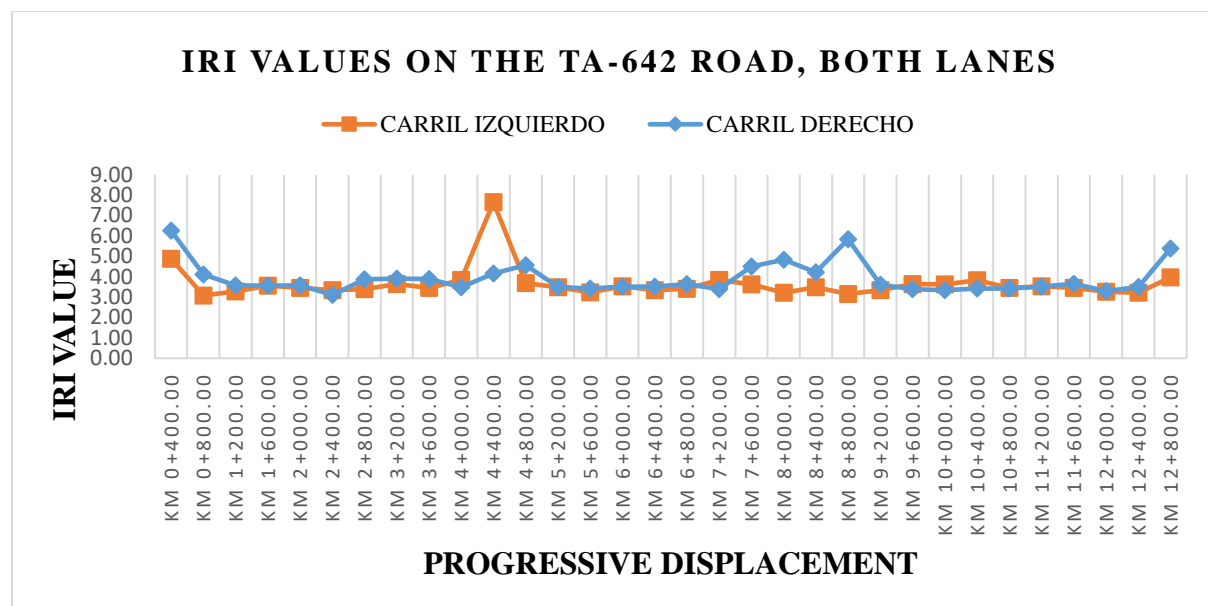
Figure 7 provides a comparison between the IRI values of both lanes. It is noted that although the left rail has a lower average, it features higher peaks than the right, suggesting that despite its better average, it has sections with significantly worse rolling conditions.

IRI value behavior every 400 m, in both lanes

Figure 7 provides a visual comparison between the IRI values of both lanes. It is observed that, although the left lane has a lower average, it presents higher values in certain sections, which suggests that, despite its better overall performance, there are sections that require urgent attention. This is crucial, as variations in roughness can influence road safety, increasing the risk of accidents and affecting the comfort of users.

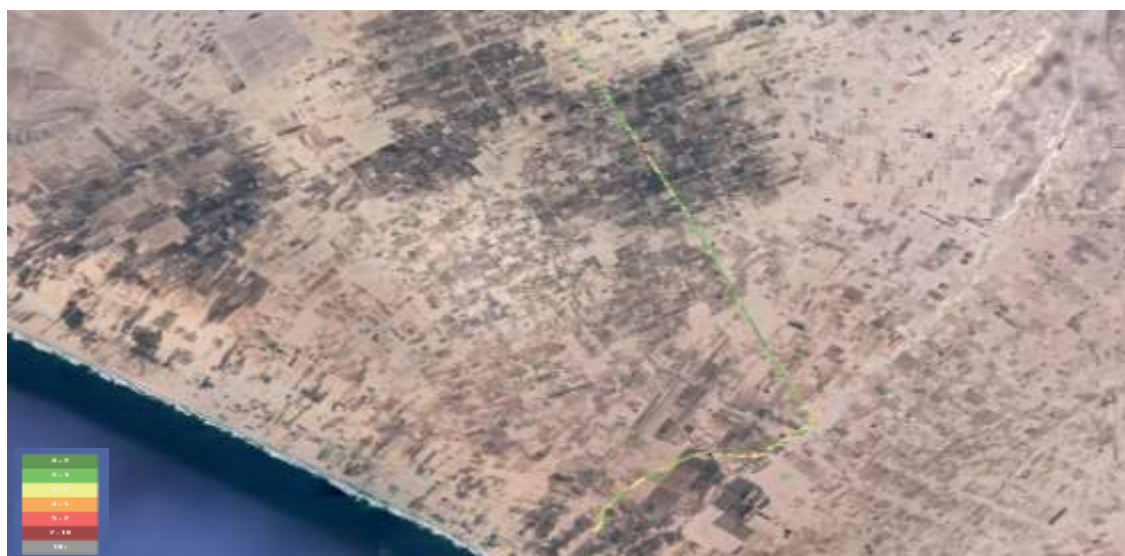
Finally, Figure 8 shows the evaluation path on both lanes using the TotalPave application, with a color code indicating the quality of the IRI. This visual representation makes it easy to identify critical stretches that need immediate attention.

Right and left lane assessment tour using the TotalPave app

Figure 8 shows the road assessment course using the TotalPave app, highlighting sections with different IRI levels via colour coding. Areas in red indicate a high IRI, allowing for quick identification of sections that require intervention, this visual representation is valuable for road managers as it makes it easier to prioritise corrective actions based on the severity of the deterioration.
