# Effects of Soil Sulfate Exposure on Surface Concrete Elements in Coastal Residential Buildings

This study investigates the effects of soil sulfate exposure on surface concrete elements in residential buildings in Parish on October 18, Canton of Portoviejo, Manabí, addressing a significant gap in local knowledge. From May to October 2023, 20 soil samples were collected and Geo-graphic Information Systems (GIS) were used for exposure mapping. Tests were performed according to the ASTM D2487 and ASTM C1580 standards to classify soil types and measure sulfate concentrations, following the Ecuadorian Construction Standard (NEC-SE-HM-2015) and ACI 318-19 guidelines. The findings revealed a predominance of clay soils (7 CH and 10 CL) and silt soils (2 MH and 1 ML), with moderate to very severe sulfate concentrations. These concentrations were associated with visible damage to the concrete structures, including efflorescence and surface erosion. This study provides a detailed classification map of sulfate exposure and its effects on concrete, offering crucial insights for future construction and repair projects in the region. The results highlight the importance of selecting appropriate

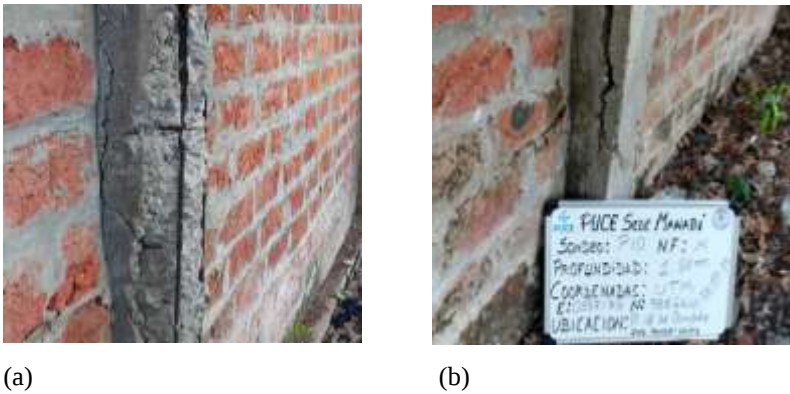
Sulfate damage in concrete causes various symptoms, depending on the intensity and duration of exposure. An early indicator is efflorescence, with whitish crystals on the surface caused by the evaporation of soluble salts [2]. Additionally, the expansion caused by ettringite formation can lead to the appearance of cracks, delamination,

and bulging on the concrete surface. In the advanced stages, mass loss and the formation of voids or cavities within the concrete can occur (Fig.3).

Figure 3. (a) Corrosion of reinforcing steel in a perimeter column near borehole P-10 due to very severe sulfate conditions in the soil. (b) Cracking and steel corrosion in another column of the same perimeter wall.

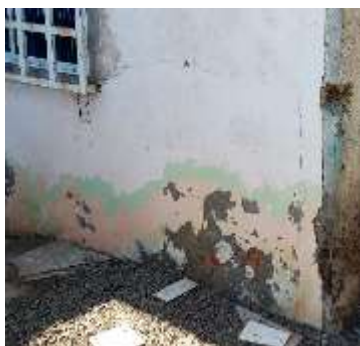
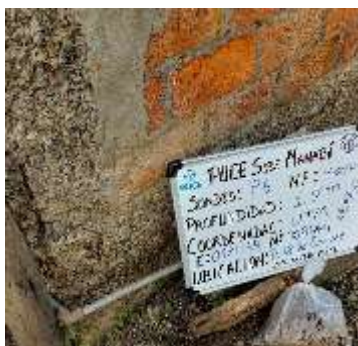
Figure 10. (a) Erosion of concrete and masonry elements on the front facade of the residential building near borehole P6. (b) Surface erosion on the column and beam observed at borehole P6, with a groundwater table at 1.0 m depth.

Additionally, the study identified various concrete pathologies associated with different sulfate exposure levels. In boreholes P-6 and P-7, surface concrete erosion was observed (Fig.10), classified as Moderate-S1 and Severe-S2, respectively, demonstrating a detrimental chemical reaction between soil sulfates and concrete components. Choosing sulfate-resistant MS and HS cement types in these areas could have mitigated this type of deterioration. The corrosion of steel reinforcements in boreholes P-10 Very Severe-S3 and P-18 Severe-S2 (Fig.11), with high sulfate concentrations, highlights the need for using HS cement and pozzolans or slags, highly resistant to sulfates, in zones of severe and very severe exposure. This measure is vital to prevent corrosion and extend the structures' service life.

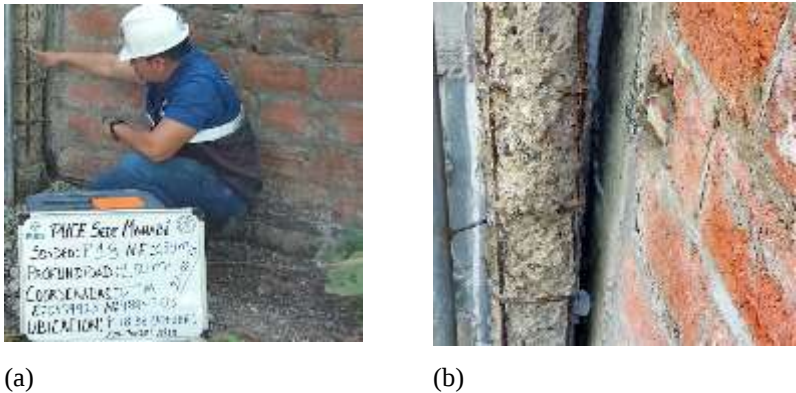
Figure 11. (a) Reinforcement corrosion in borehole P-18, with a groundwater table at 1.5 m depth. (b) Deteriorated concrete column with exposed and corroded steel reinforcement due to severe sulfate conditions, observed at borehole P-18.
